Manhole Inspection Summary

Manhole # S45K__036MH

Insp Date: **4/30/08 2:31 PM**

Location Address: **717 s ann st**

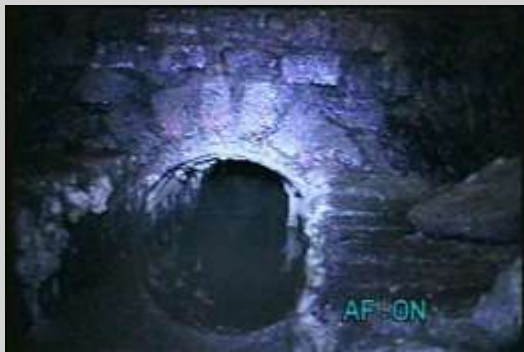
12 O'Clock Outflow

8 in. Circular Gravity Sewer
Pipe Out @ 12 O'Clock

Invert Depth: **14.70** (ft.) Flow Characteristics: **Fast**

Infiltration: **None** Pipe Seal Cond: **Unknown**

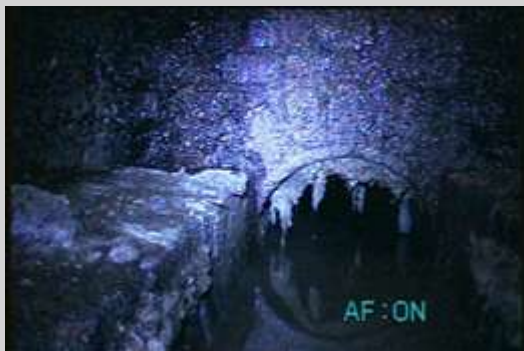
6 O'Clock Inflow

8 in. Circular Gravity Sewer
Pipe In @ 6 O'Clock

Bench Debris

Invert Depth: **14.50** (ft.) Flow Characteristics: **Fast**

Infiltration: **None** Pipe Seal Cond: **Unknown**
